My name is Shanena Barnes, and I am here today to testify in support of LD 1927: An Act to Protect Housing Quality by Enacting Mold Inspection, Notification and Remediation Requirements.

Re: Mold Assessment at 65 Whitney Street (Apartment 1) property in Auburn, Maine.

AQM Project #: 24-928

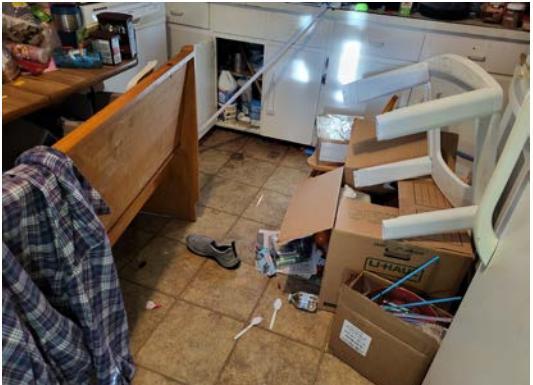
View of floor and sink cabinet

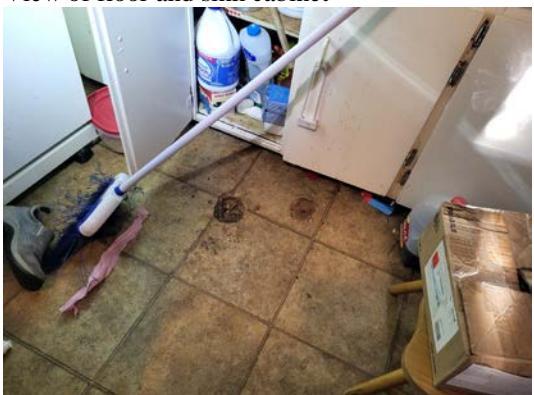
- Water damage and mold growth was observed inside the Kitchen sink cabinet. The floor at the sink cabinet measured wet. Water has or is leaking from sink plumbing.

Floor is damaged at sink cabinet

- Remove floor system in front of sink cabinet. In general, remove two feet in each direction of damage. Remove floor to single layer sub-deck.
- Bedroom 1:

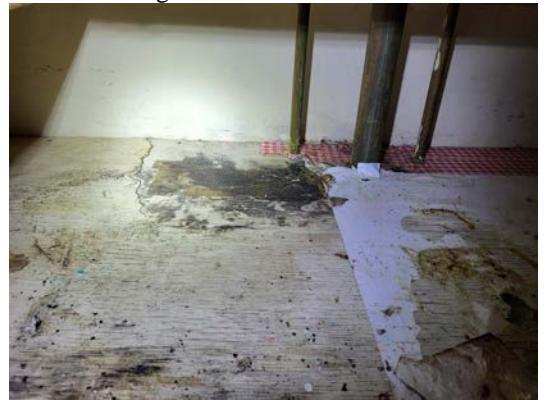
Mold growth inside sink cabinet

- <u>Kitchen:</u>
 - Remove base of sink cabinet. Evaluate underlying surfaces (i.e. floor and wall) for damages and remove if found to be water damaged and moldy.

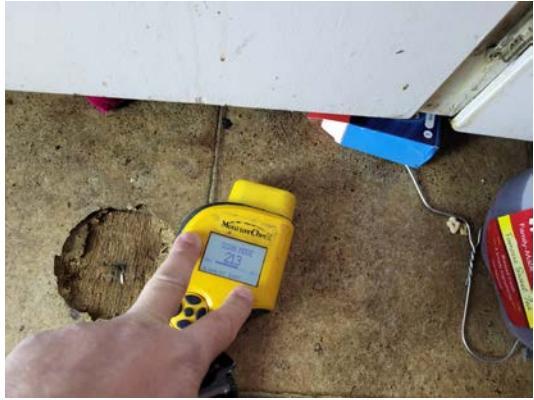
Floor at sink cabinet is wet

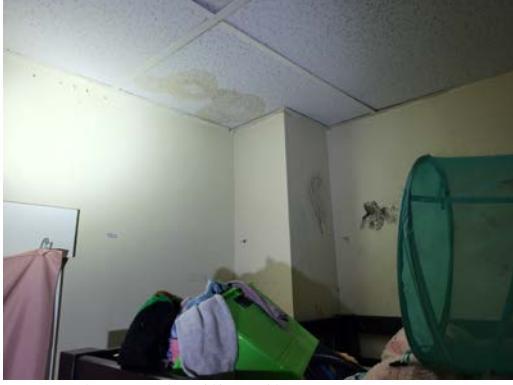
- Water damage observed on ceiling tile and surfaces above ceiling tile in Bedroom 1. Mold growth was observed on wall and strapping on surfaces above ceiling tile. Damages appear consistent with reported water damage.

Water damaged ceiling tile

- Remove ceiling system (ceiling tile and plaster / lathes) in area of water damage and mold growth. In general, remove two feet in each direction of damage.

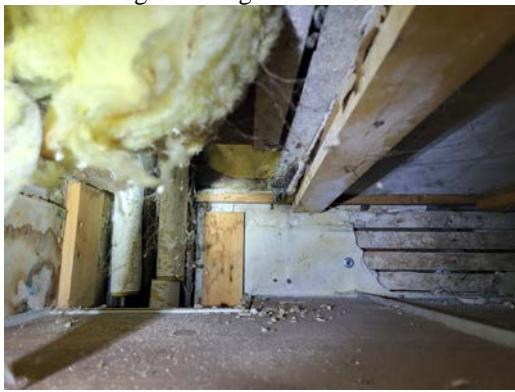
Water damage on surfaces as viewed from above ceiling tiles

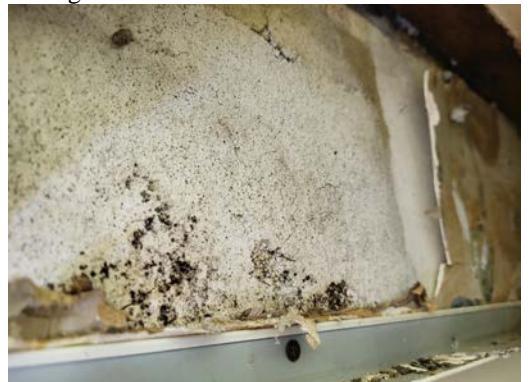
Mold growth on wall, wall above ceiling tile

- Remove wall system, floor to ceiling, on each side of the pipe chase. In general, remove two feet out in direction of pipe chase.
- <u>Master Bedroom:</u>

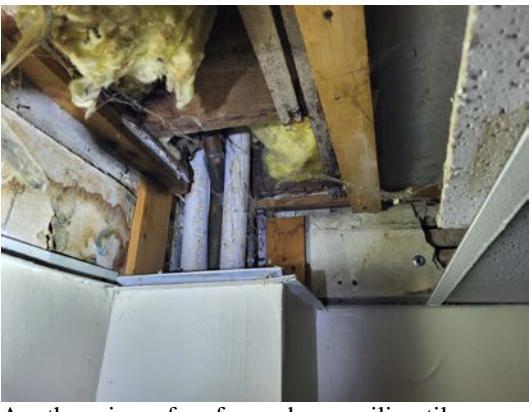
Another view of surfaces above ceiling tile

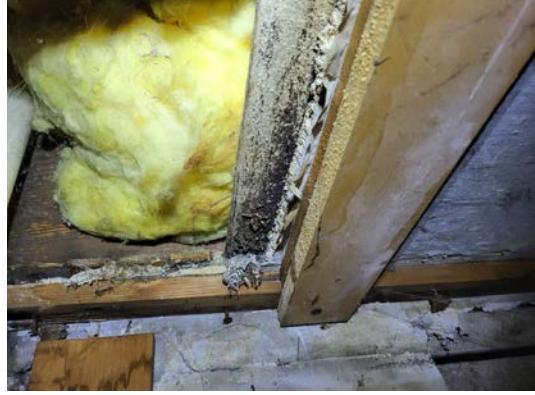
Mold growth on ceiling strapping

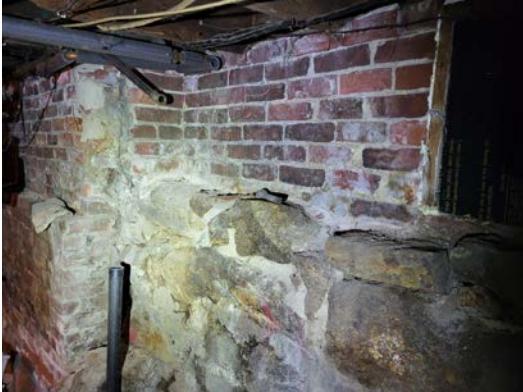
- Foundation dampness most Basement humidity issues are due to lack of adequate dehumidification and general foundation dampness caused by chronically wet soil surrounding the foundation. Conditions that promote wet soil close to the foundation are: lack of gutters or gutters with downspouts that do not carry water well-away from the foundation, land that slopes downward toward the foundation and shielding from sunlight by trees and other vegetation.

Water has been observed leaking in foundation

- Consult a Professional Engineer or a competent qualified contractor to control groundwater intrusion into the Basement and/or prevent saturated soil surrounding the foundation / slab by: installing exterior foundation perimeter drainage, sloping the ground away from the foundation / slab 5% (6" for every 10"), installing gutters (If gutters are to be installed ensure they are kept free of debris and the downspouts direct water well-away from the foundation), and water proofing the foundation walls or utilizing other like systems. May consider installation of sump (fitted with pump) in the Basement.

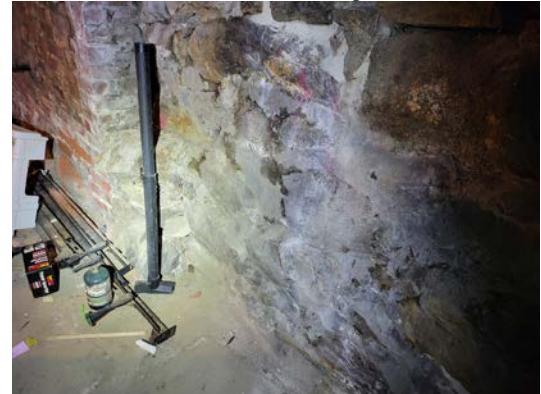
Water observed pooling on floor

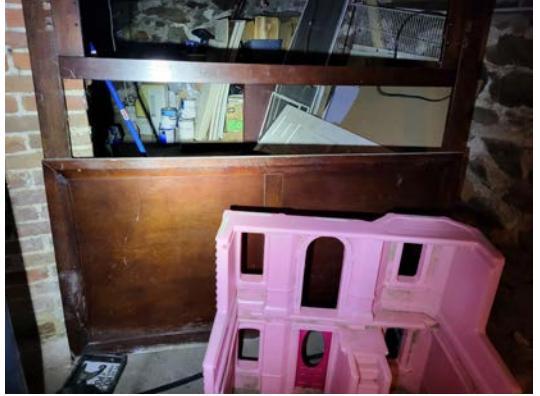
Mold growth on items

- Personal contents / furniture (in Basement) have significant microbial impact and should be evaluated by the restoration specialists for cleaning or disposal. Valuable items may be identified and restored if feasible.

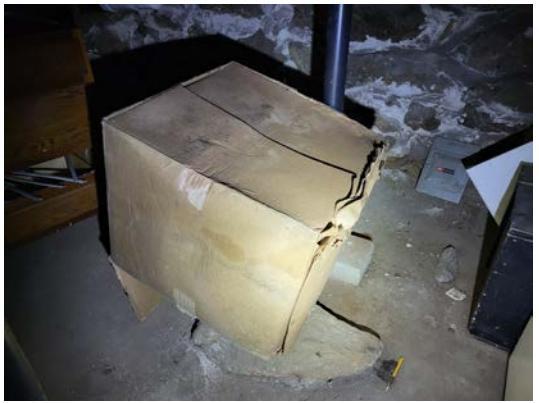
Mold on box

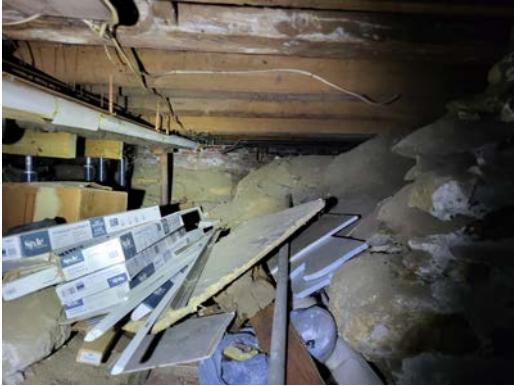
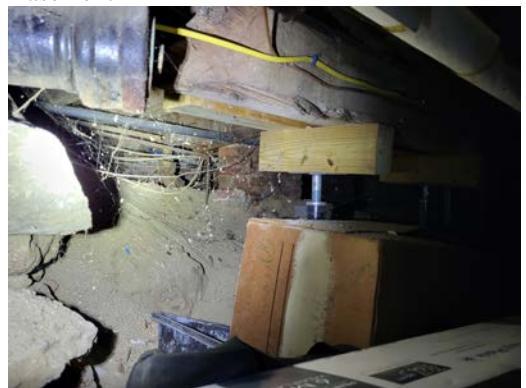
- Attached to the Basement is an exposed dirt floor Crawlspace. Moisture can evaporate and migrate through the dirt and exacerbate moisture issues.
- In general, humidity issues in a Home are related to lack of adequate dehumidifier use in the Basement, general foundation dampness, and general humidity issues (from environmental humidity and lack of use). Other possible issues are inadequate (use of) or lacking exhaust fans at appliances (above stove and dryer) or in Bathroom(s).

There is an attached dirt floor Crawlspace off Basement

• Also consider permanently enclosing dirt floor in the Crawlspace and protect via dehumidification as described above. Cover soil with suitable vapor barrier such as the Cleanspace System (Basement Systems, Inc.) or equivalent. Install sump pump if deemed necessary; ensure that water does not accumulate directly under the membrane and cannot pool on the top surface of the membrane.

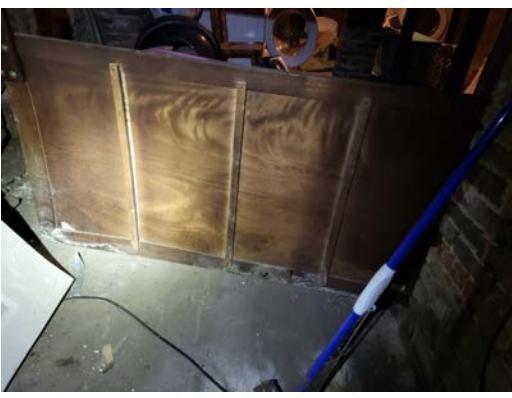
Another photo showing mold on item

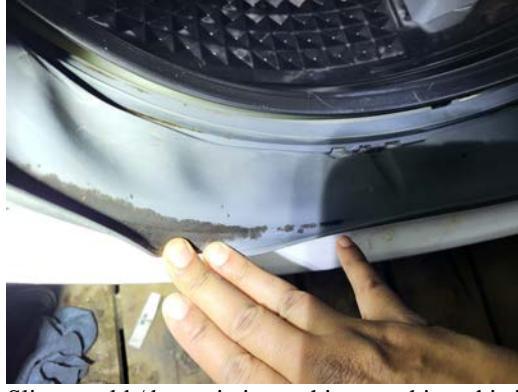
- Mold / bacterial film observed on gasket of washing machine door. This is typically associated with dampness. Water can accumulate in the gasket when in use and after use and promote mold growth if the door is kept closed after use.

Slime mold / bacteria in washing machine, this is typical if door is closed after using

- This level of cleaning shall be used for the washer machine gasket.

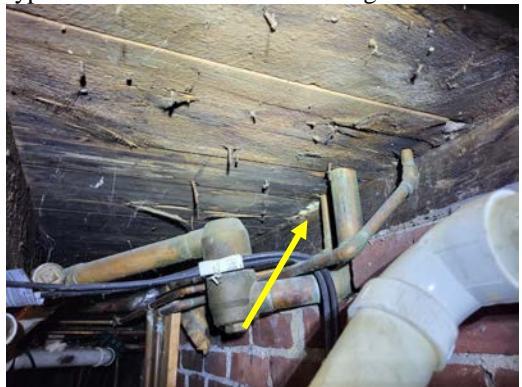
- Floor in Bathroom measured wet. Water likely leaking from shower.
- Water damage observed on Master Bedroom Ceiling.
- Mold growth was observed on the Basement Ceiling in area under the Kitchen Sink, likely from water leaking from Kitchen sink. Mold growth was also observed on items stored in the Basement. Mold growth on items and contents in the Basement is typically associated with surface condensation from uncontrolled humidity. Client reported observing water leaking in the Basement, from foundation, and pooling on floor. Water intrusion in the Basement can also exacerbate moisture and humidity issues in the Basement.

Water damage and mold growth on ceiling area, area under Kitchen

- Remove all attachments on the ceiling (i.e. duct work and fiberboard, if present) to affect cleaning.
 - Remove all attachments on walls (i.e. pegboards / shelving units / plywood panels, if present) to affect cleaning.

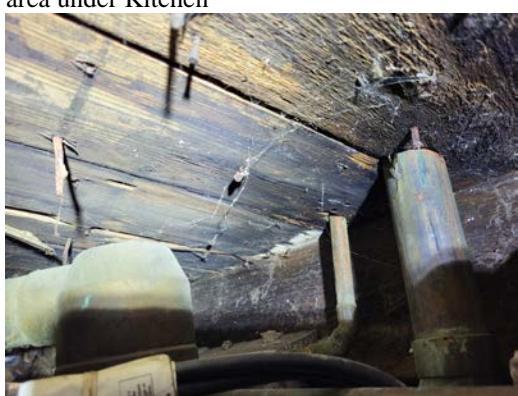
Close-up of area in previous photo

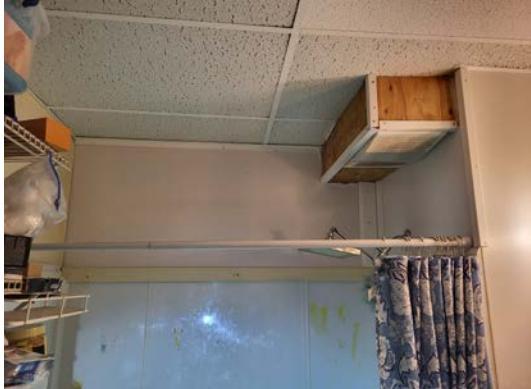
There is an exhaust fan

- Ensure to control humidity in the Home. Ensure that the bathroom ceiling exhaust fan(s), dryer exhaust, Kitchen stove exhaust and/or or any other appliance exhaust are installed, properly sealed and operated and vent directly outdoors to prevent humidity issues indoors that can lead to structural impact / mold growth in the Attic and/or other indoor locations. Control humidity in the Basement by use of dehumidifier adequate for the space and/or amount of dampness and humidity present (April Aire or equivalent dehumidifier). Maintain Basement humidity at 40% or less (there is no specific level that will work in all homes). Monitor humidity to ensure proper levels.

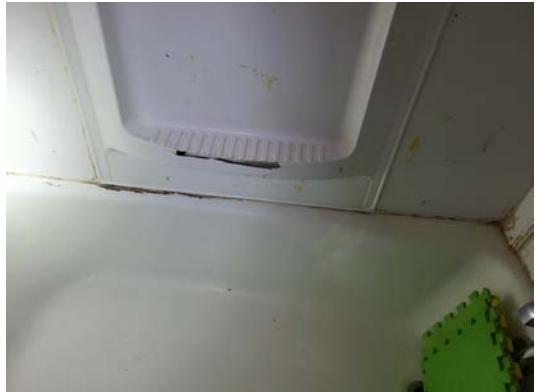
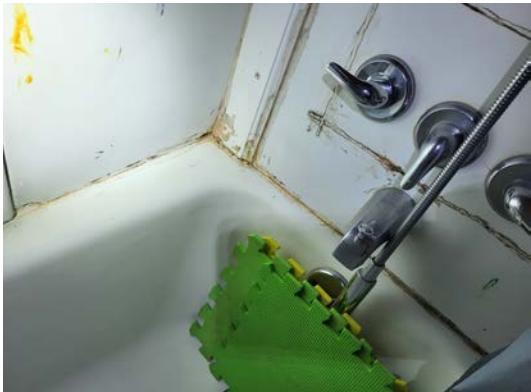
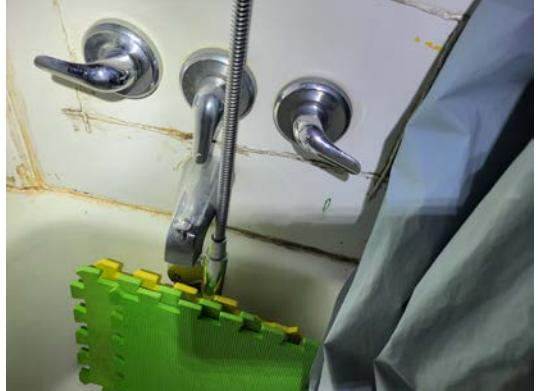
Shower walls not well sealed

- Ensure shower system is water tight.

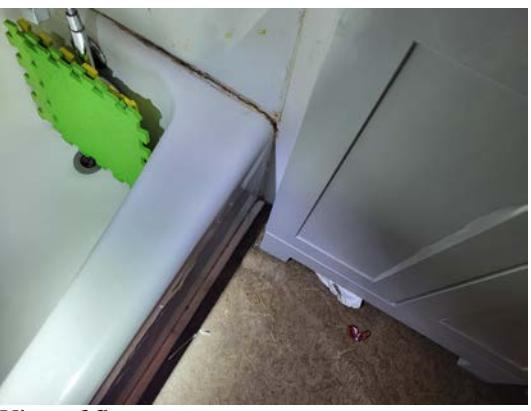
View of floor

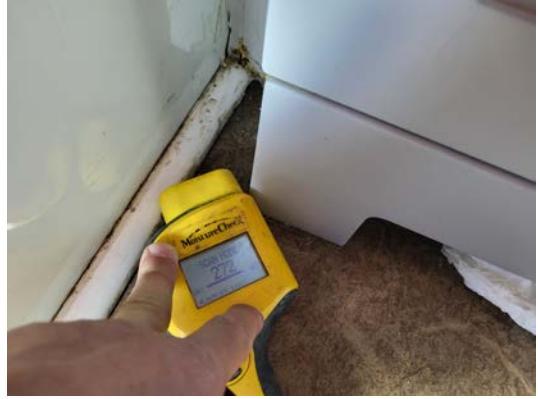
Floor measured wet

- Remove ceiling system in area of water damage. In general, remove two feet in each direction of damage.
- <u>Bathroom:</u>
 - Remove floor system in front of shower and at Vanity. In general, remove two feet in each direction of damage. May need to remove Vanity to affect floor system removal. Remove floor to single layer sub-deck.

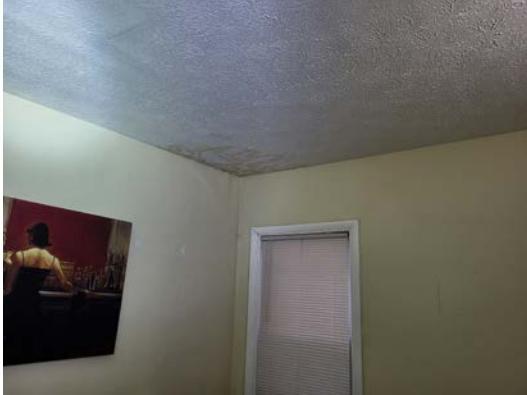
Water damaged ceiling

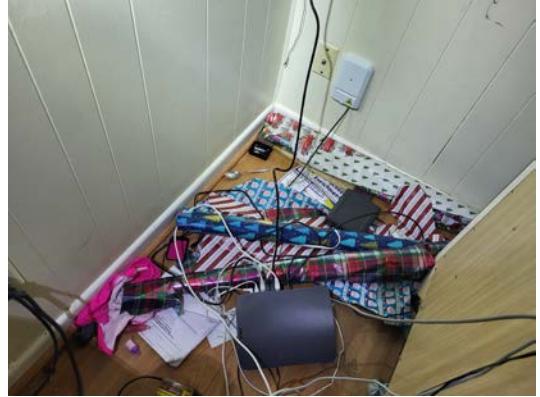
No signs of water damage on lower wall or floor
