These were taken in just the last 2 weeks at my shop for vehicles coming in for inspection. These are the vehicles you share the road with. Thank you for your time and urge you to strongly consider supporting LD 667.

Handout provided by: Michael Guay, owner of Jims Auto Repair Inc. and Sticker Station Inc., verbal testimony in favor of LD 667.

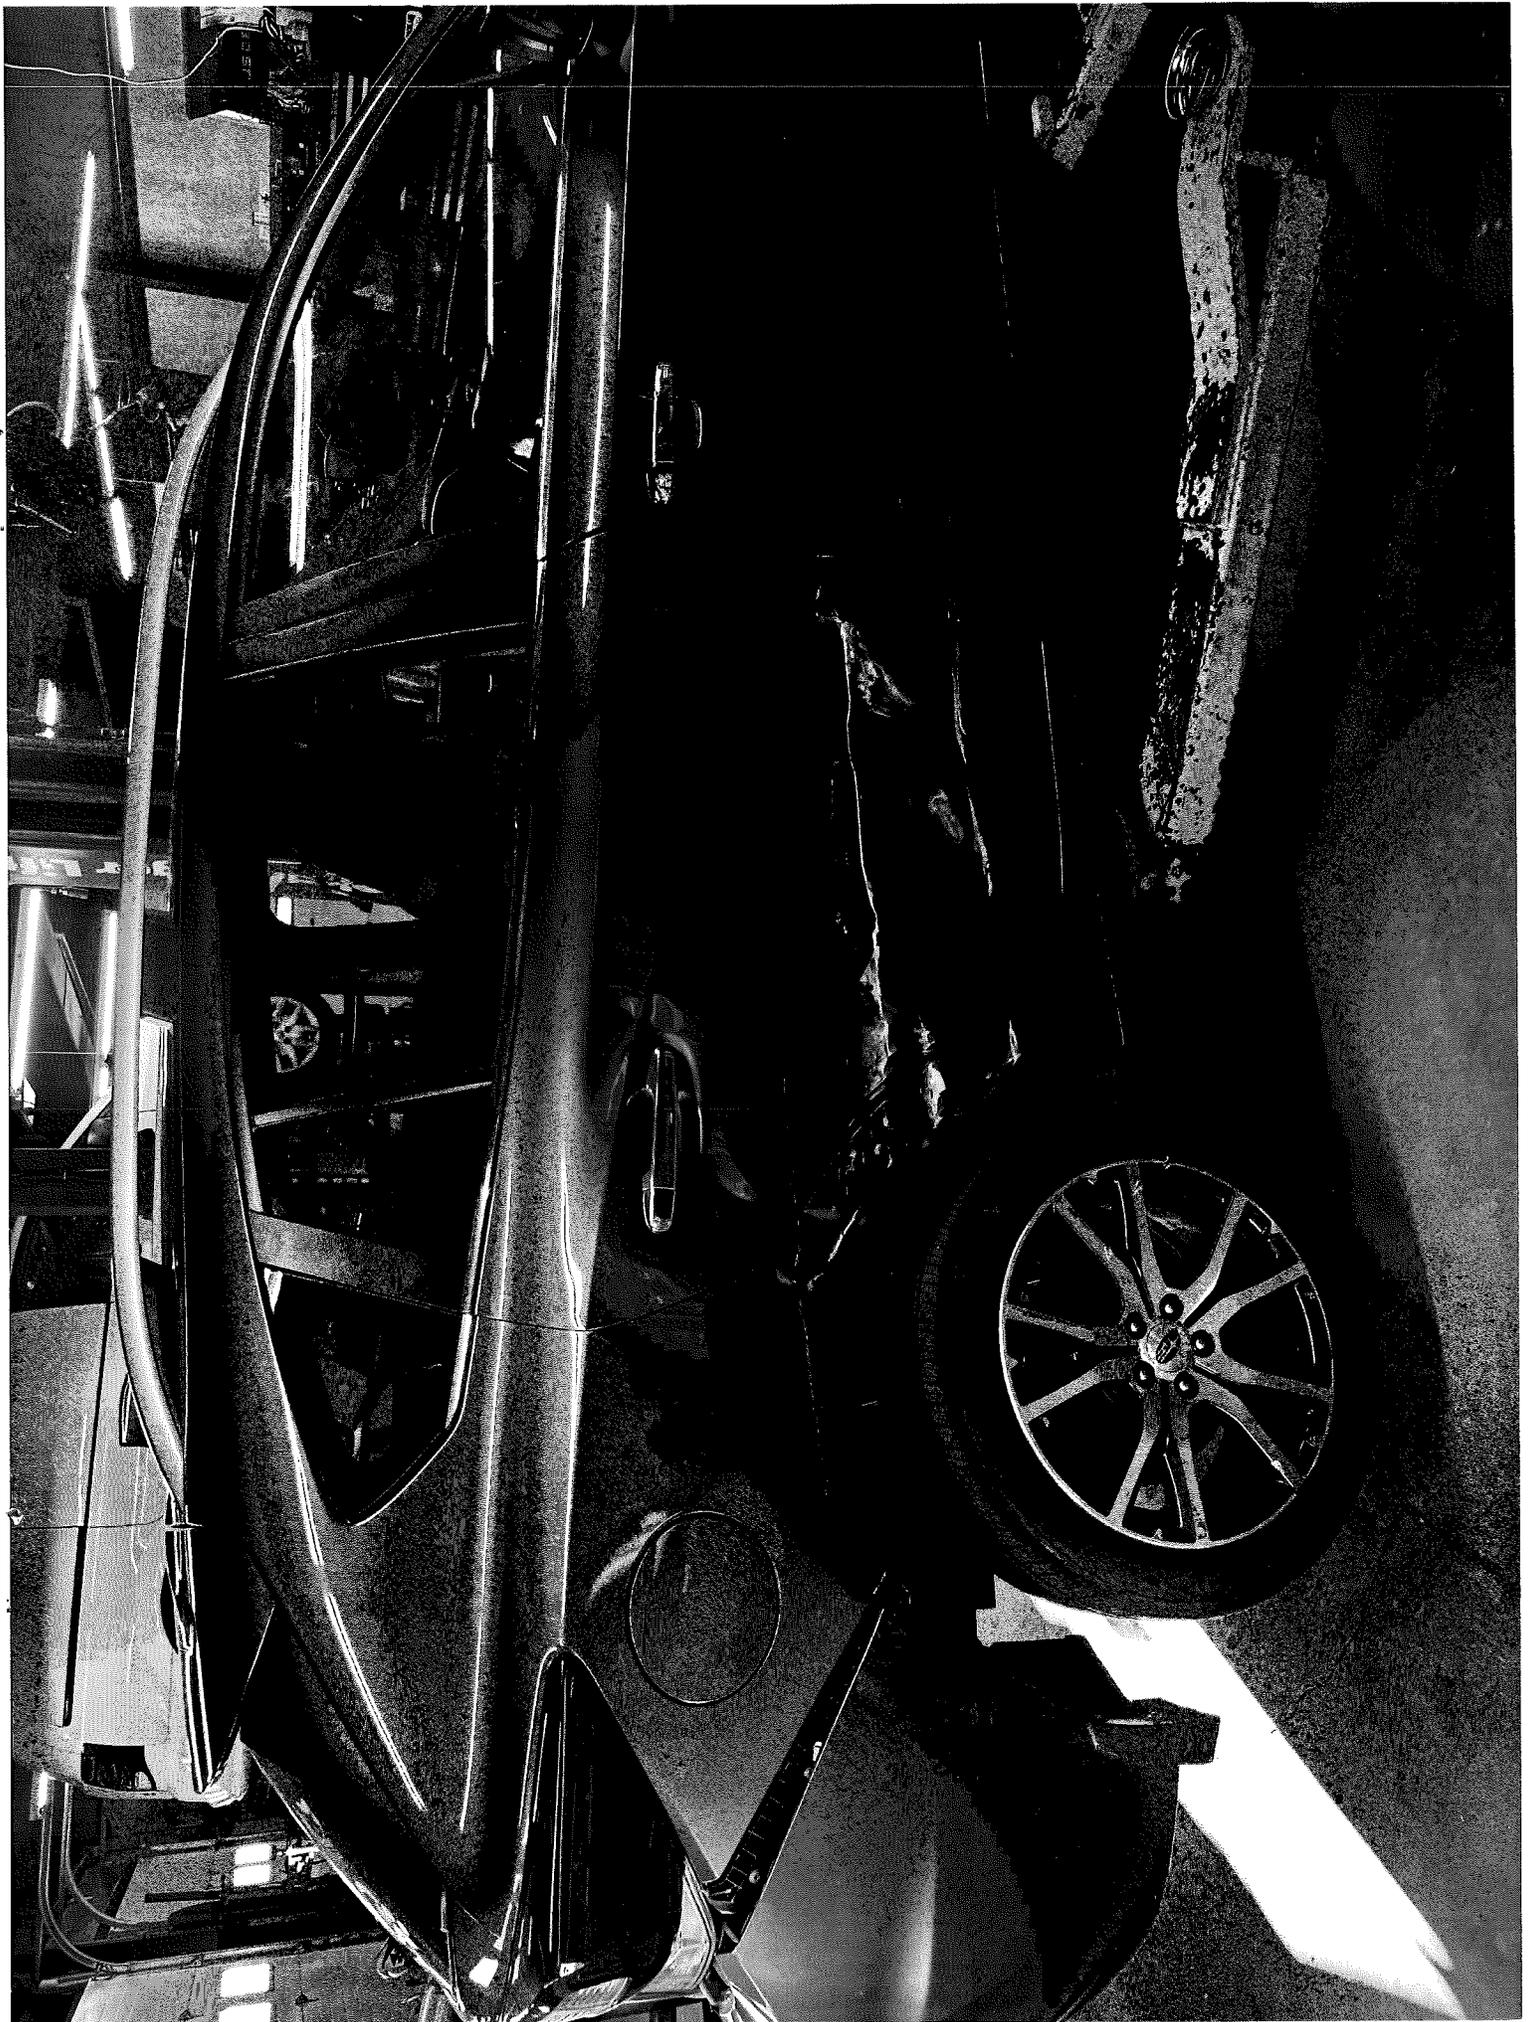
- 1- Customer requested safety inspection knowing full well the condition of vehicle→ extreme damage should've been assessed by insurance/ body shop, not worth time for \$12.50.

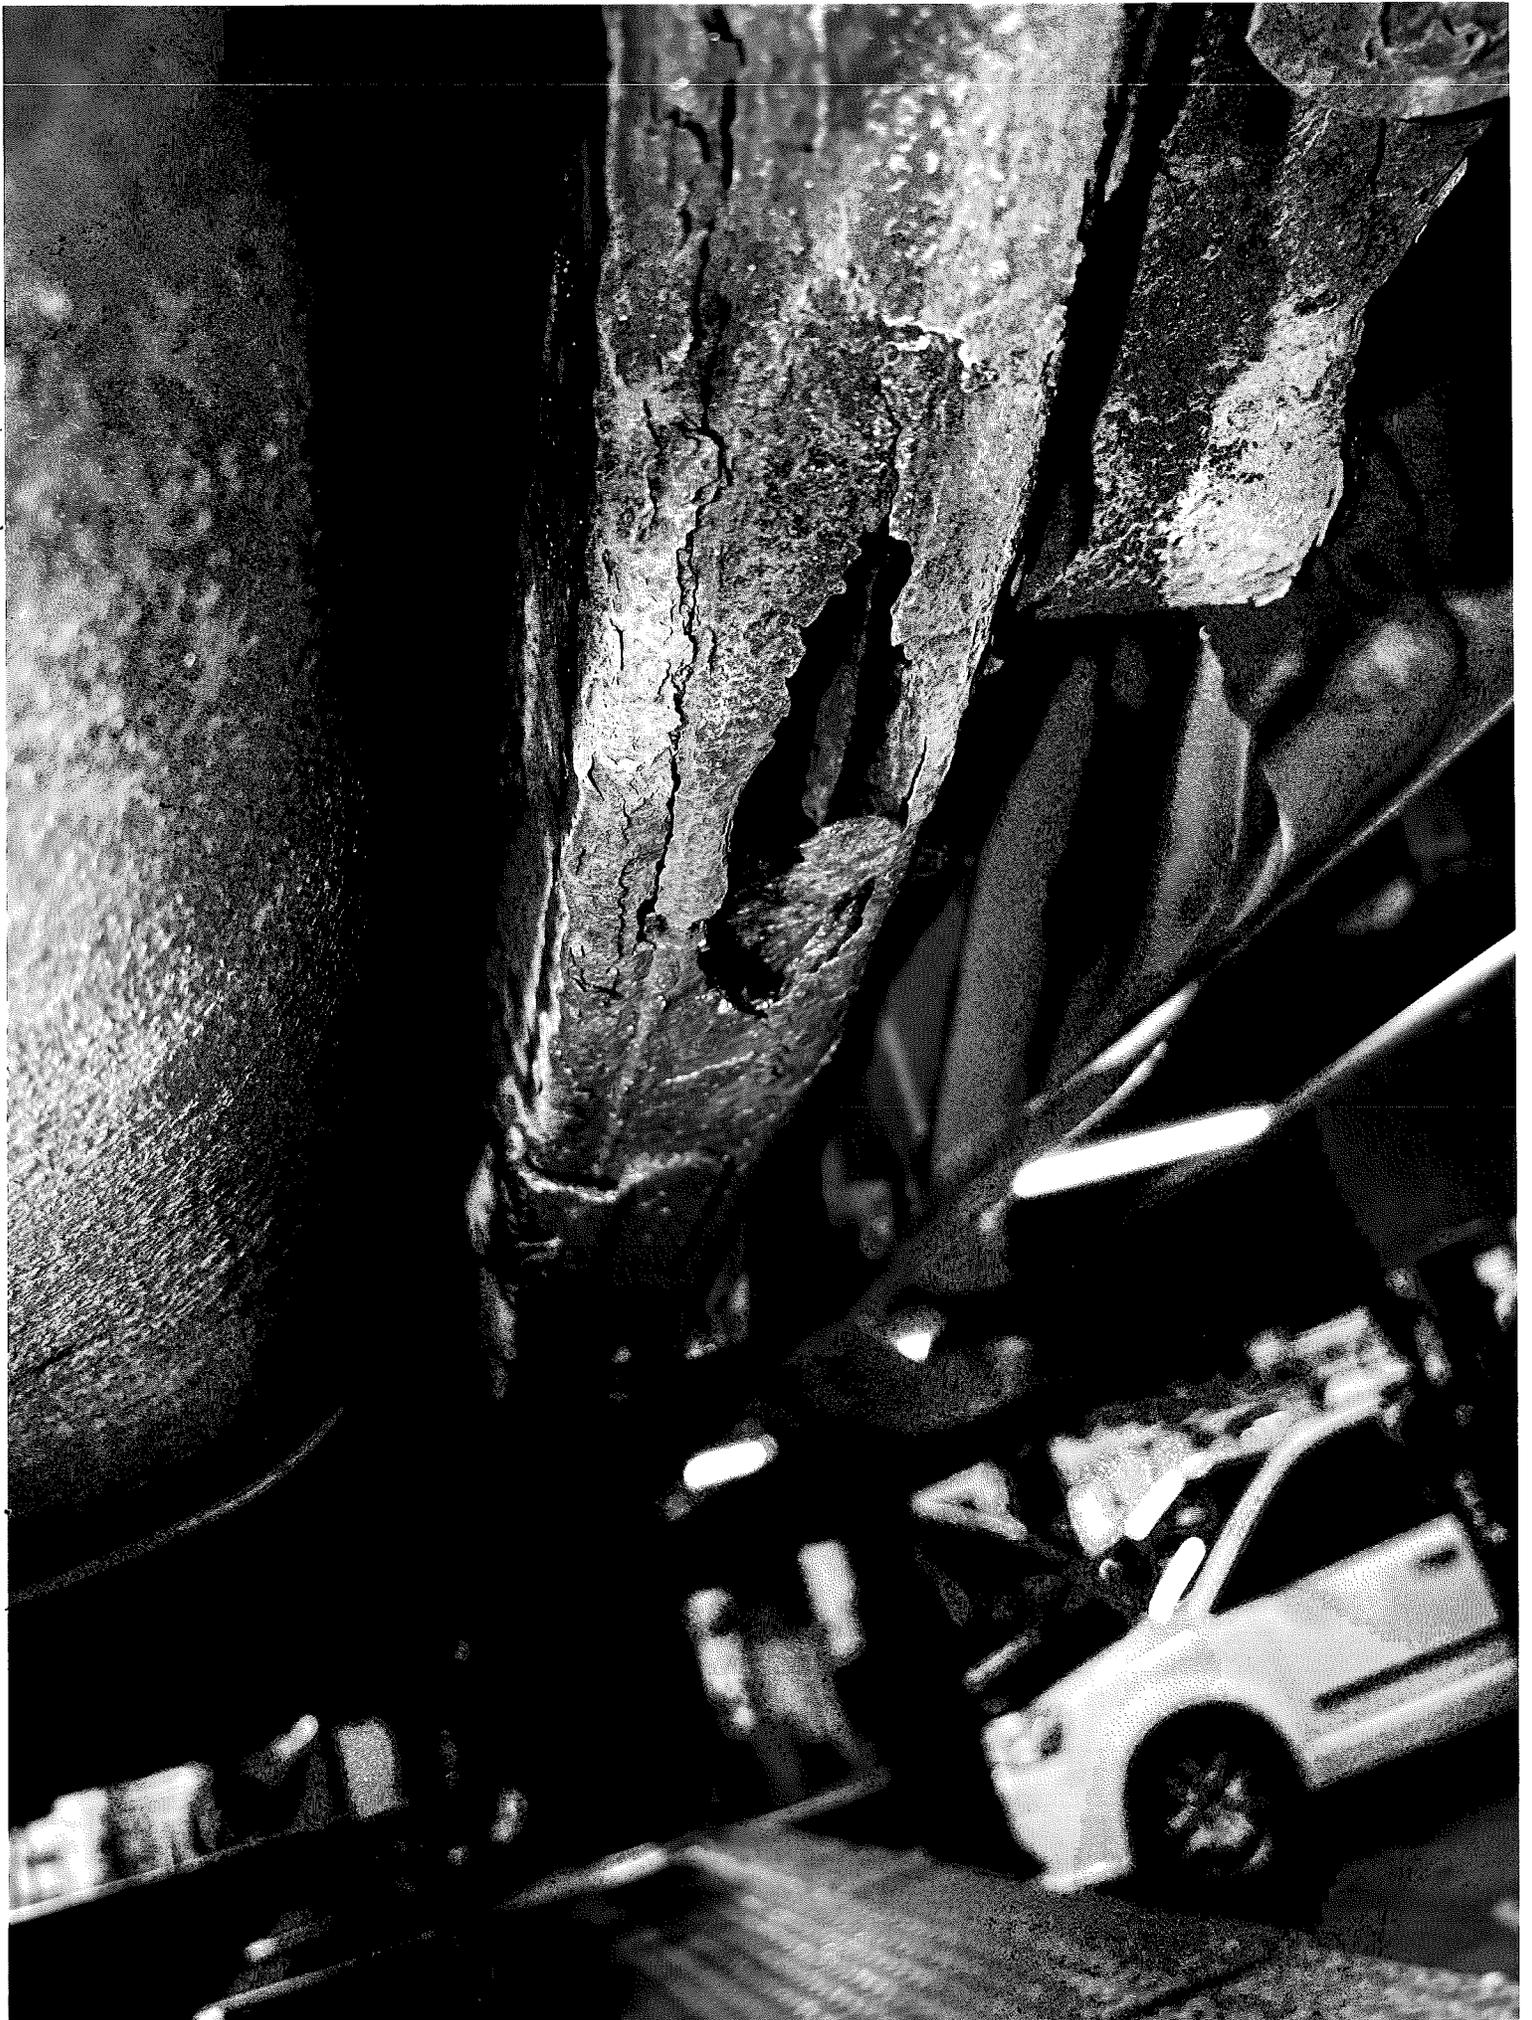
- 2- Frame rot
- 3- Brake line ready to blow (cracked/blistering/rusted)
- 4- Frame hole at rear shackle mount
- 5- Same vehicle.. more rust holes present

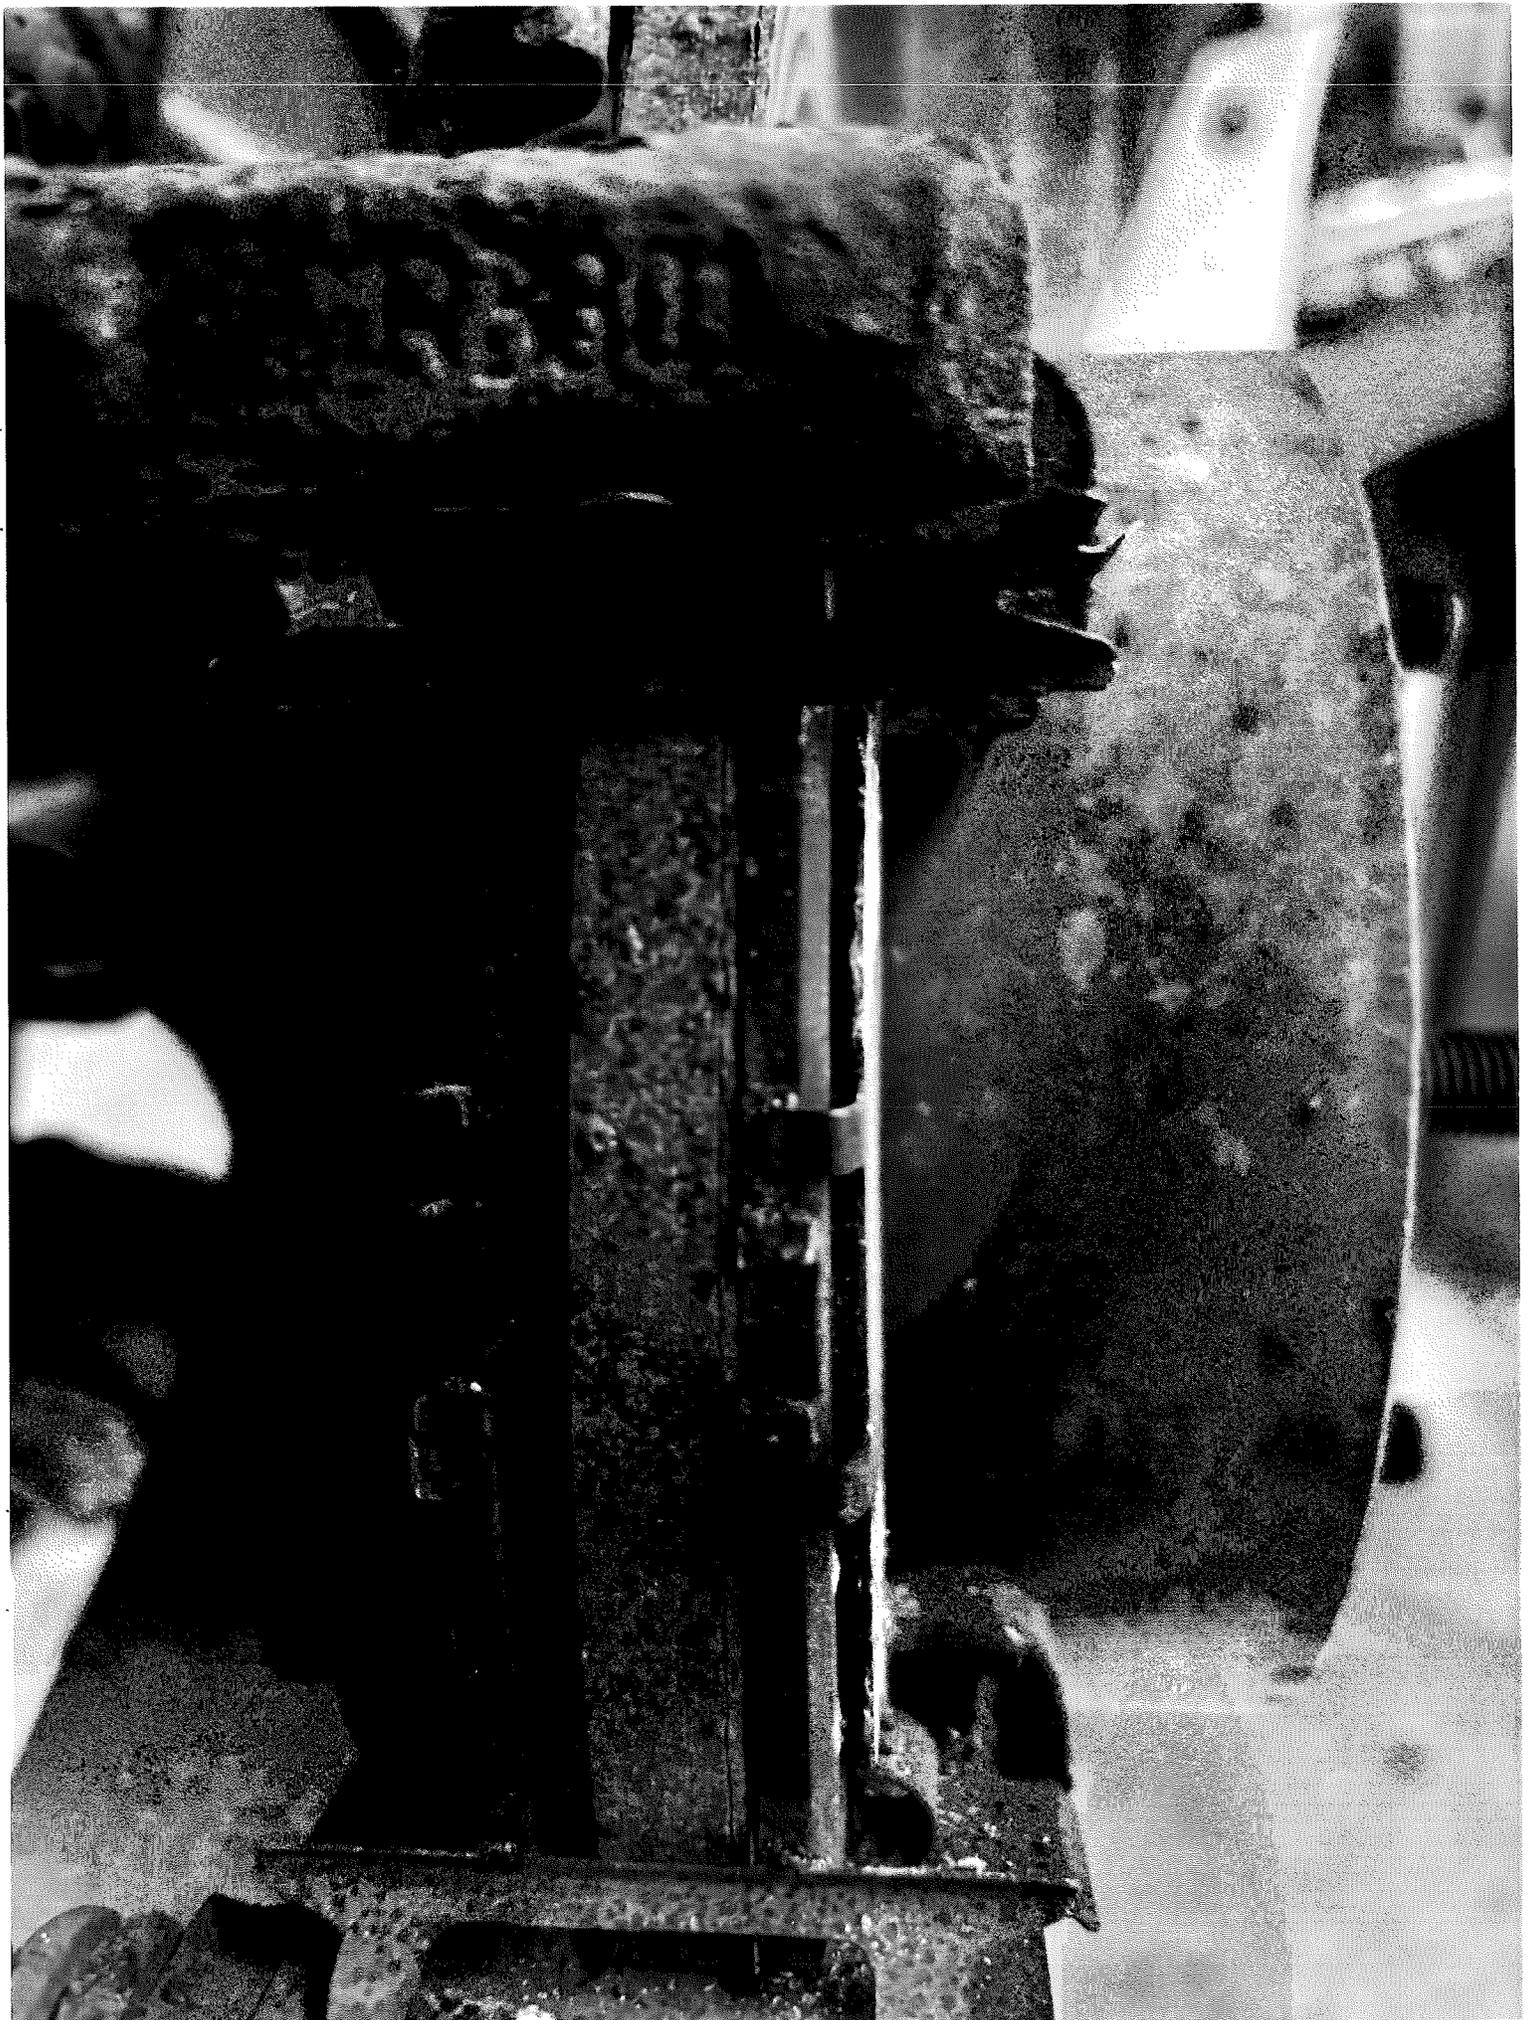
- 9- Right outer brake pad down to metal to metal
- 10- Exhaust hole in pipe at hanger
- 11- Bald tire
- 12- Vehicle is missing a rear spring (fell out from the rust of the cradle arm letting go)

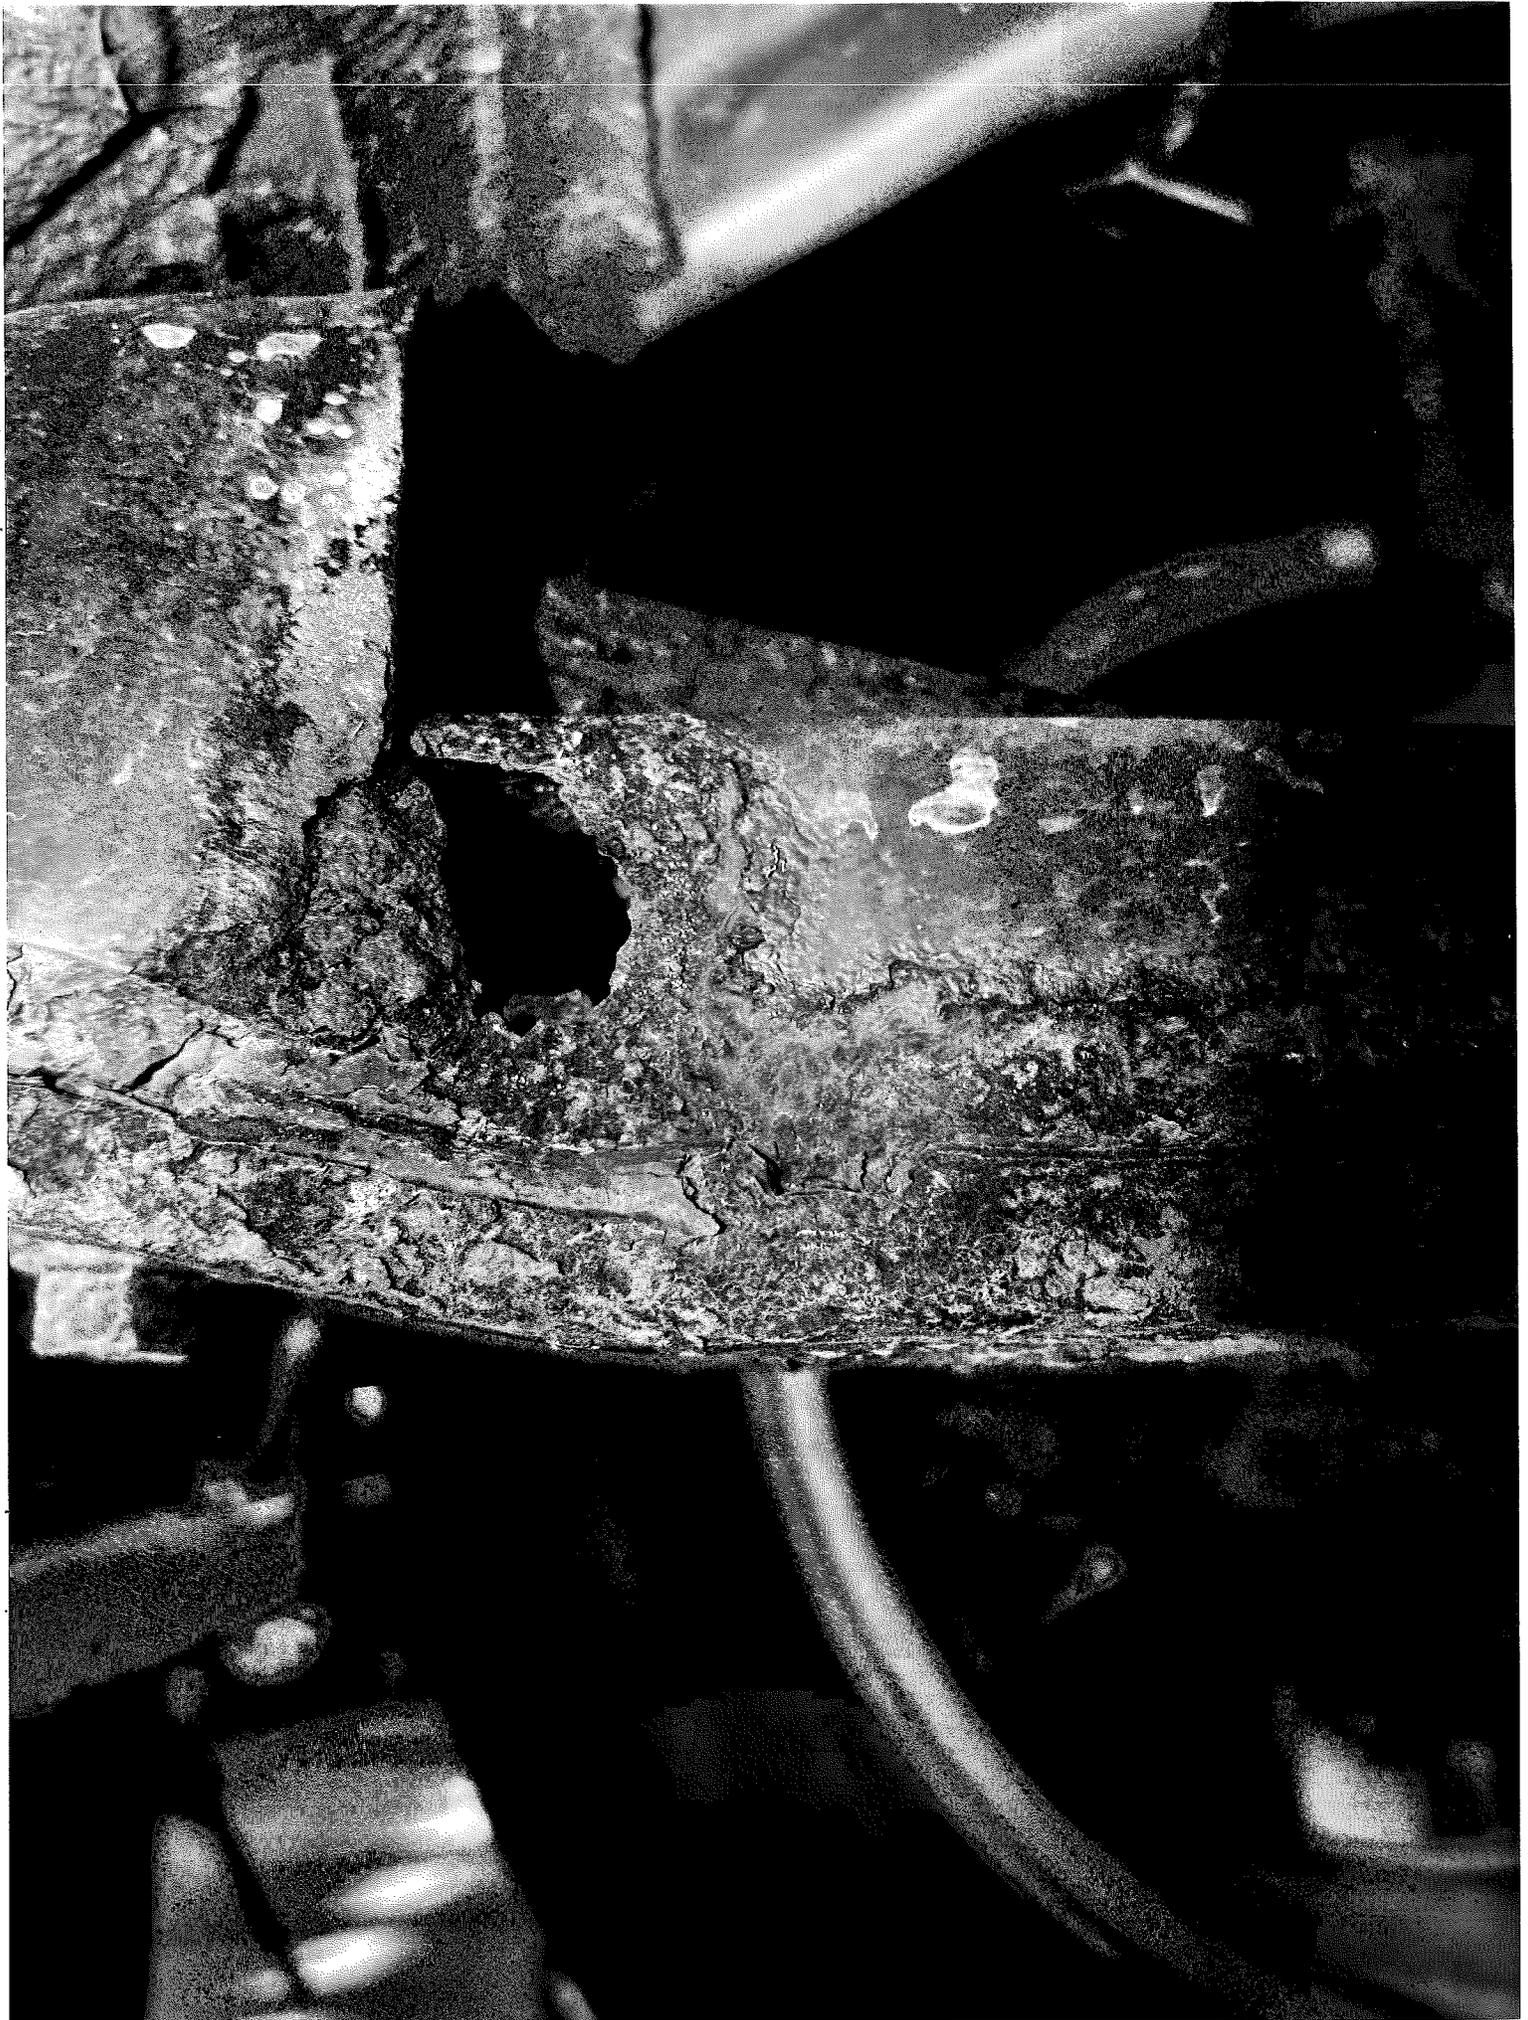
- 13- Front cross member frame rot hole
- 14- Constant velocity shaft boot torn, axle shaft pulled out of place, grease slinging on braking surface
- 15- More frame rot

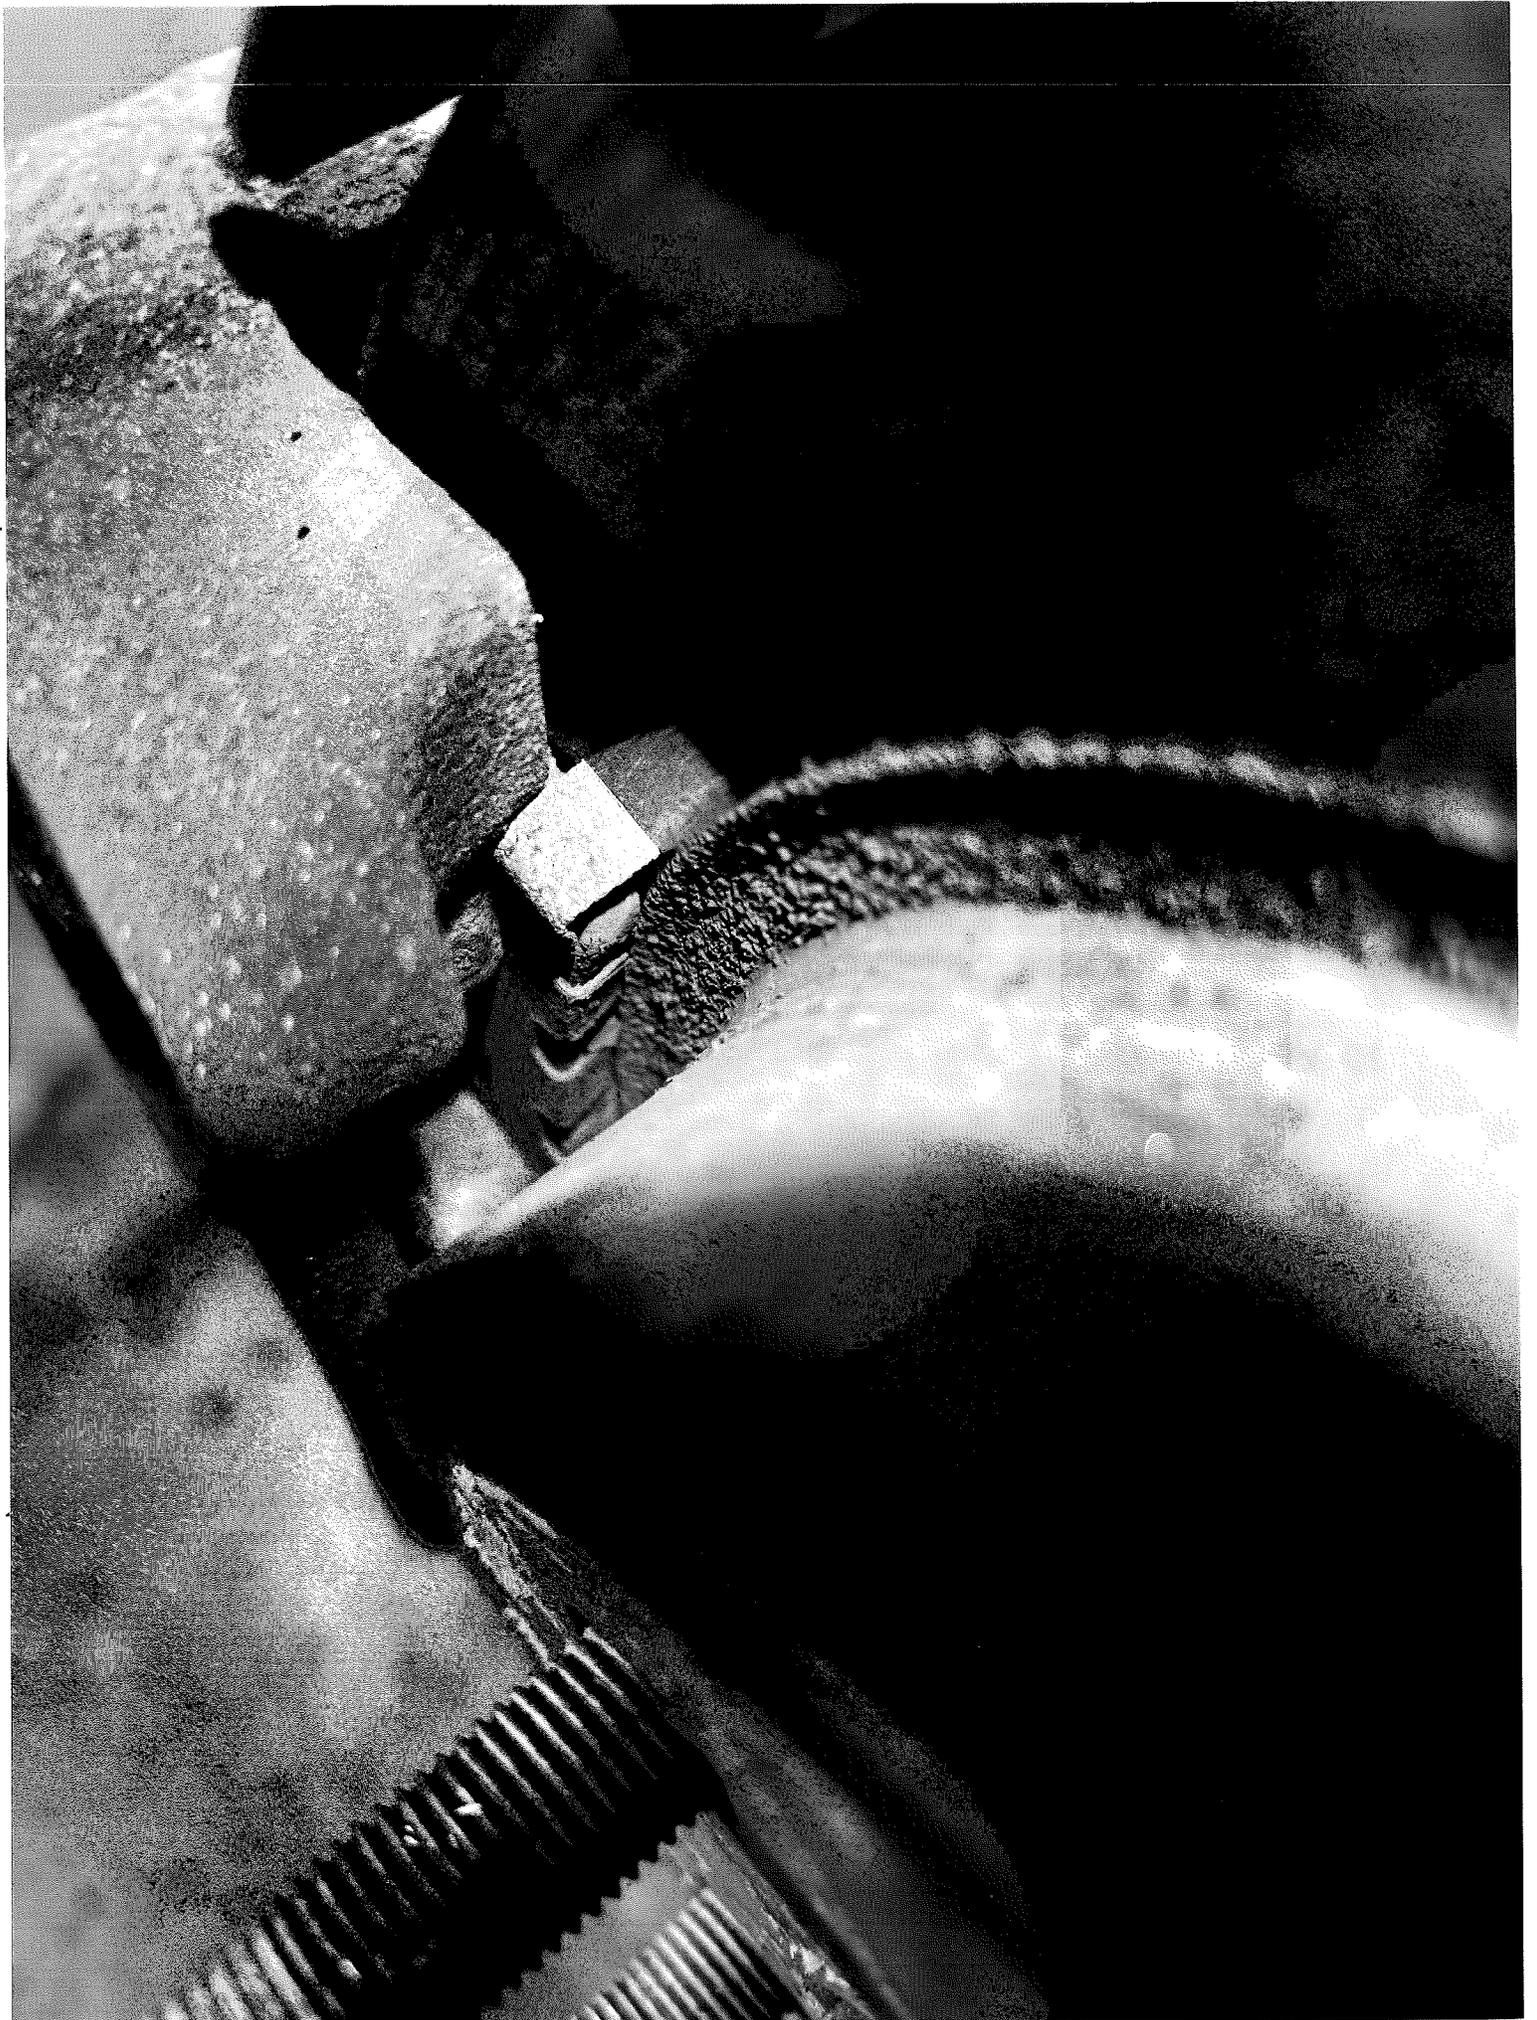
- 18- No brake pad, metal to metal
